Flood Control Project Maintenance
2018 Structure Summary Report
Overall Unit and Item Ratings

DWR Sutter Maintenance Yard

Butte Slough Drainage Structure

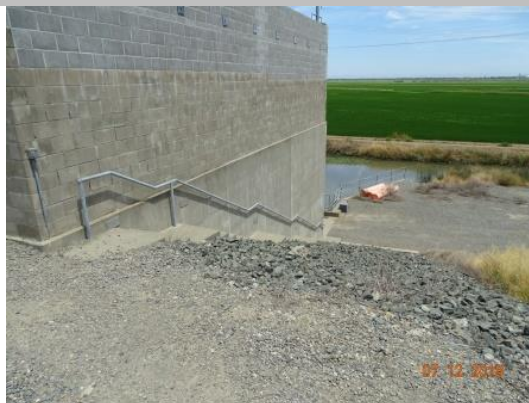
Photo 6 of 6 : ST_2018_NA0060_21_5_20180713_00043.jpg

LM Start	0.00	Rating **	M	Issue No.	5 (cont)	
LM End	0.00	Issue Type +	Ma	Location *		
Category	Pump Stations			GPS Latitude/Longitude		
				Start	End	
Item	Safety			38.931815 °	38.931815 °	
				-121.634331 °	-121.634331 °	
DWR ID	DWR_NA0060_21_t_2012_5					
Action/Comments						
Inspector Comments: Missing fall protection railing at the pump inlet.

Photo of stair railing going down to pump inlet.

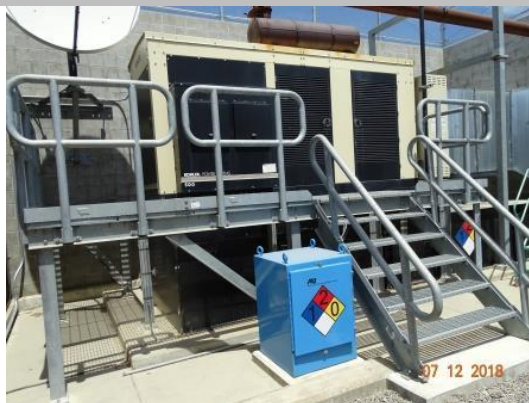
Photo 1 of 1 : ST_2018_NA0060_21_8_20180713_00032.jpg

LM Start	0.00	Rating **	A	Issue No.	8
LM End	0.00	Issue Type +	Ma	Location *	
Category	Pump Stations	GPS Latitude/Longitude			
		Start	End		
Item	Power	38.931815 °		38.931815 °	
		-121.634331 °		-121.634331 °	
DWR ID	DWR_NA0060_21_t_2012_8				
Action/Comments					
Inspector Comments: The structure is on the grid with emergency backup generator.

View of the backup generator. Photo taken July, 2018.

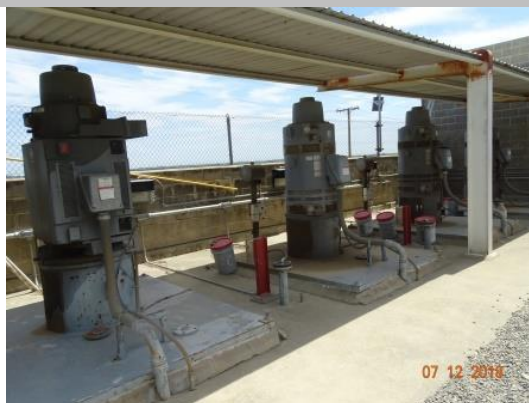
Photo 1 of 2 : ST_2018_NA0060_21_10_20180713_00033.jpg

LM Start	0.00	Rating **	A	Issue No.	10
LM End	0.00	Issue Type +	Ma	Location *	
Category	Pump Stations			GPS Latitude/Longitude	
				Start	End
Item	Motors, Engines, Fans & Gear Reducers			38.931815 °	38.931815 °
				-121.634331 °	-121.634331 °
DWR ID	DWR_NA0060_21_t_2012_10				
Action/Comments					
Inspector Comments: These items appear to be maintained and in operating condition.

View of the pump motor. Photo taken July, 2018.

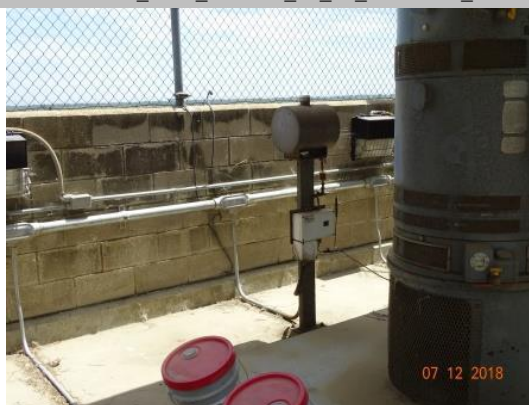
Photo 2 of 2 : ST_2018_NA0060_21_10_20180713_00034.jpg

View of oil tank. Photo taken July, 2018.

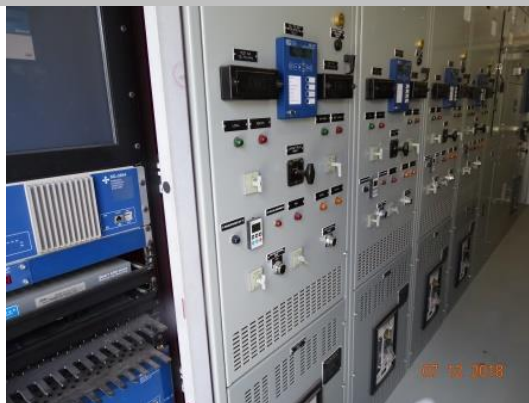
Photo 1 of 1 : ST_2018_NA0060_21_11_20180713_00035.jpg

LM Start	0.00	Rating **	A	Issue No.	11
LM End	0.00	Issue Type +	Ma	Location *	
Category	Pump Stations			GPS Latitude/Longitude	
				Start	End
Item	Pump Control Systems			38.931815 °	38.931815 °
				-121.634331 °	-121.634331 °
DWR ID	DWR_NA0060_21_t_2012_11				
Action/Comments					
Inspector Comments: Pump control systems on site are new and appear to be in working order.

View of the pump control panels. Photo taken July, 2018.

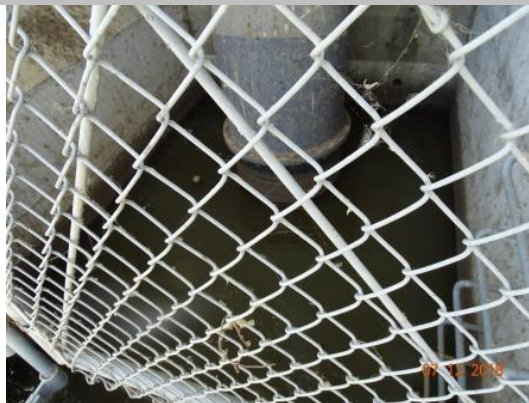
Photo 1 of 1 : ST_2018_NA0060_21_12_20180713_00036.jpg

LM Start	0.00	Rating **	A	Issue No.	12	
LM End	0.00	Issue Type +	Ma	Location *		
Category	Pump Stations			GPS Latitude/Longitude		
				Start	End	
Item	Sumps/Wet Well			38.931815 °	38.931815 °	
				-121.634331 °	-121.634331 °	
DWR ID	DWR_NA0060_21_t_2012_12					
Action/Comments						
Inspector Comments: Sumps are clear and free of debris.

View of pump sump that is represents the other sumps. Photo taken July, 2018.

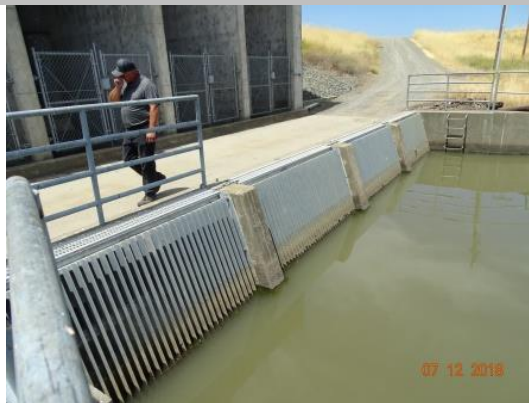
Photo 1 of 1 : ST_2018_NA0060_21_13_20180713_00037.jpg

LM Start	0.00	Rating **	A	Issue No.	13
LM End	0.00	Issue Type +	Ma	Location *	
Category	Pump Stations			GPS Latitude/Longitude	
				Start	End
Item	Trash Racks			38.931815 °	38.931815 °
				-121.634331 °	-121.634331 °
DWR ID	DWR_NA0060_21_t_2012_13				
Action/Comments					
Inspector Comments: No debris present on trash racks, they appear to be in good condition.

View of trash racks at the pump inlet. Photo taken July, 2018.

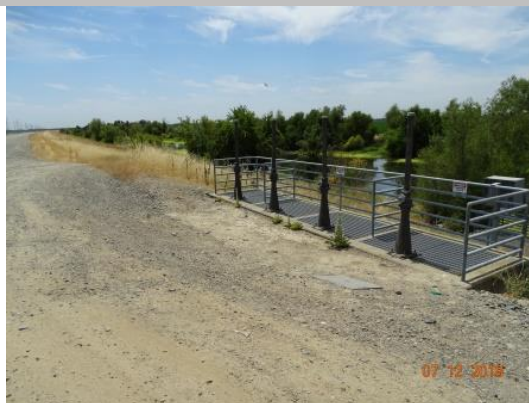
Photo 1 of 1 : ST_2018_NA0060_21_17_20180713_00038.jpg

LM Start	0.00	Rating **	A	Issue No.	17
LM End	0.00	Issue Type +	Ma	Location *	
Category	Pump Stations			GPS Latitude/Longitude	
				Start	End
Item	Manual Gate Operators			38.931815 °	38.931815 °
				-121.634331 °	-121.634331 °
DWR ID	DWR_NA0060_21_t_2012_17				
Action/Comments					
Inspector Comments: Manual gate operators appear to be in good working condition.

View of manual gate operators. Photo taken July, 2018.

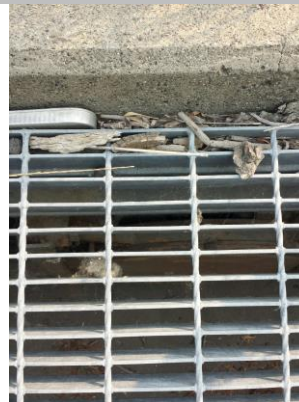
Photo 1 of 1 : ST_2018_NA0060_21_19_20180816_00045.jpg

LM Start	0.00	Rating **	A	Issue No.	19
LM End	0.00	Issue Type +	Ma	Location *	
Category	Pump Stations			GPS Latitude/Longitude	
				Start	End
Item	Flap Gates			38.931815 °	38.931815 °
				-121.634331 °	-121.634331 °
DWR ID	DWR_NA0060_21_t_2012_19				
Action/Comments					
Inspector Comments: Flap gates are in proper working condition, they show no obvious signs of damage.

View of typical flap gate. All flap gates are closed and in good condition. Photo taken July, 2018.

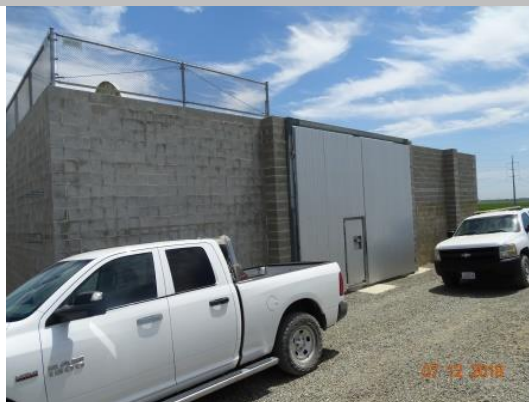
Photo 1 of 1 : ST_2018_NA0060_21_21_20180713_00040.jpg

LM Start	0.00	Rating **	A	Issue No.	21
LM End	0.00	Issue Type +	Ma	Location *	
Category	Pump Stations			GPS Latitude/Longitude	
				Start	End
Item	Security Fencing			38.931815 °	38.931815 °
				-121.634331 °	-121.634331 °
DWR ID	DWR_NA0060_21_t_2012_21				
Action/Comments					
Inspector Comments: Site is secured by a masonry brick wall and steel gate.

View of concrete security fence and steel security door. Photo taken July, 2018.

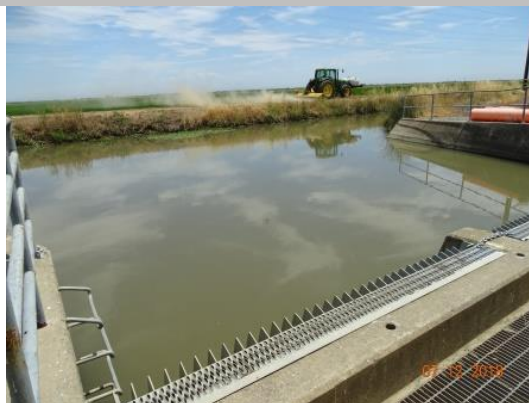
Photo 1 of 1 : ST_2018_NA0060_21_22_20180713_00042.jpg

LM Start	0.00	Rating **	A	Issue No.	22
LM End	0.00	Issue Type +	Ma	Location *	
Category	Pump Stations			GPS Latitude/Longitude	
				Start	End
Item	Intake and Discharge Pipes			38.931815 °	38.931815 °
				-121.634331 °	-121.634331 °
DWR ID	DWR_NA0060_21_t_2012_22				
Action/Comments					
Inspector Comments: No visible deficiencies observed in the pipe's condition.

View of the pump inlet. Photo taken July, 2018.

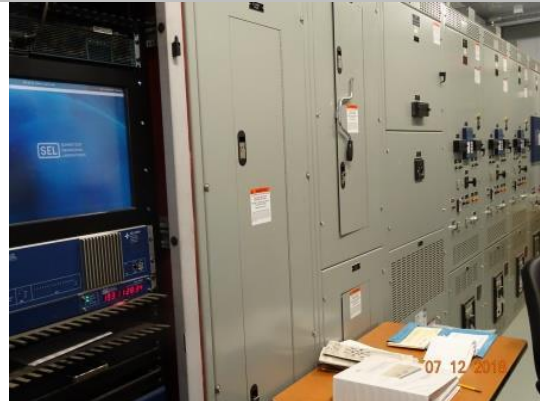
Photo 1 of 1 : ST_2018_NA0060_22_1_20180713_00024.jpg

LM Start	0.00	Rating **	A	Issue No.	1
LM End	0.00	Issue Type +	Ma	Location *	
Category	Pump Stations			GPS Latitude/Longitude	
				Start	End
Item	Operating Log			39.026449 °	39.026449 °
				-121.726937 °	-121.726937 °
DWR ID	DWR_NA0060_22_t_2012_1				
Action/Comments					
Inspector Comments: Operation log is located at the site.

View of operations log. Photo taken July, 2018.

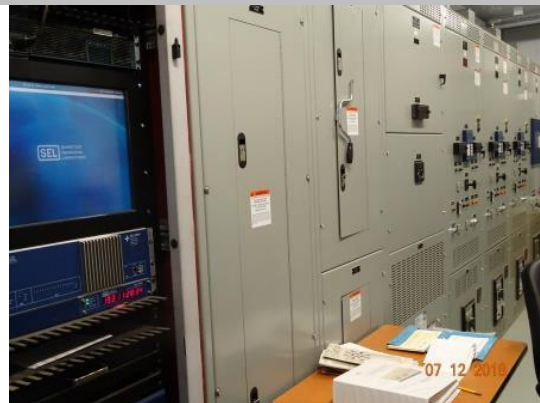
Photo 1 of 1 : ST_2018_NA0060_22_2_20180713_00025.jpg

LM Start	0.00	Rating **	A	Issue No.	2
LM End	0.00	Issue Type +	Ma	Location *	
Category	Pump Stations			GPS Latitude/Longitude	
				Start	End
Item	Operation & Maintenance Manual			39.026449 °	39.026449 °
				-121.726937 °	-121.726937 °
DWR ID	DWR_NA0060_22_t_2012_2				
Action/Comments					
Inspector Comments: O&M Manual is present at the site. Sutter Maintenance Yard will provide documentation of maintenance going forward.

View of O&M manual. Photo taken July, 2018.

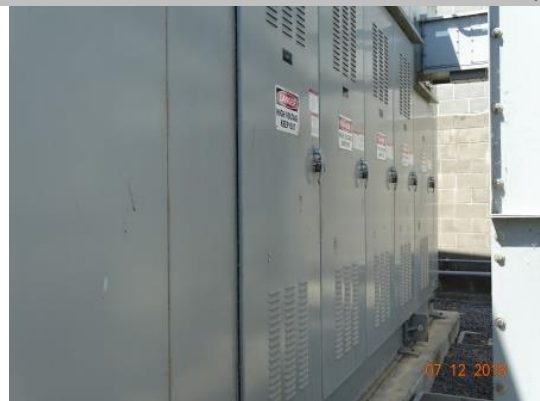
Photo 1 of 2 : ST_2018_NA0060_22_3_20180713_00031.jpg

LM Start	0.00	Rating **	A	Issue No.	3	
LM End	0.00	Issue Type +	Ma	Location *		
Category	Pump Stations			GPS Latitude/Longitude		
				Start	End	
Item	Plant Building			39.026449 °	39.026449 °	
				-121.726937 °	-121.726937 °	
DWR ID	DWR_NA0060_22_t_2012_3					
Action/Comments						
Inspector Comments: Construction finished at the site that increased the height of the building.

View of the the backside of the pump control room. Photo taken July, 2018.

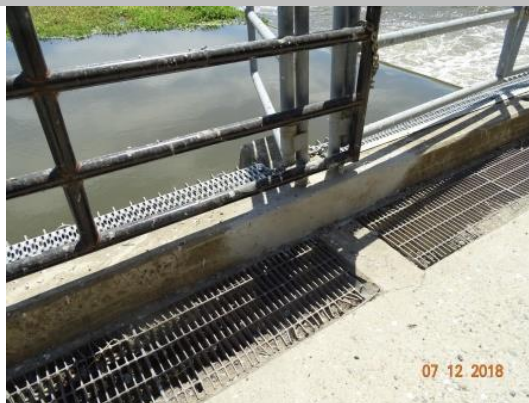
Photo 2 of 2 : ST_2018_NA0060_22_3_20180713_00032.jpg

View of fixed concrete erosion above the trash racks. Photo taken July, 2018.

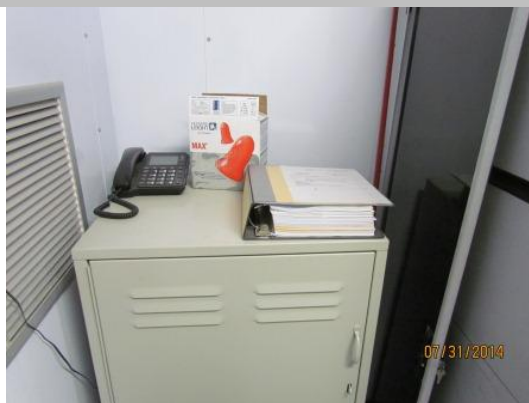
Photo 1 of 1 : ST_2018_NA0060_22_4_20180711_00005.jpg

LM Start	0.00	Rating **	A	Issue No.	4
LM End	0.00	Issue Type +	Ma	Location *	
Category	Pump Stations			GPS Latitude/Longitude	
				Start	End
Item	Communications			39.026449 °	39.026449 °
				-121.726937 °	-121.726937 °
DWR ID	DWR_NA0060_22_t_2012_4				
Action/Comments					
Inspector Comments: Operator has two-way radio and cellular phone available to them. The remote control system appears to be operational.

View of the on-site telephone. Photo taken July, 2018.

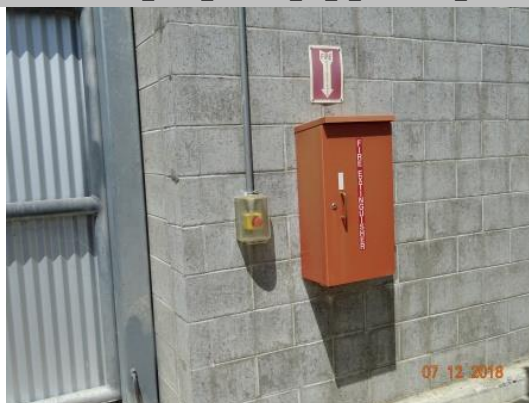
Photo 1 of 6 : ST_2018_NA0060_22_5_20180713_00027.jpg

LM Start	0.00	Rating **	M	Issue No.	5
LM End	0.00	Issue Type +	Ma	Location *	
Category	Pump Stations			GPS Latitude/Longitude	
				Start	End
Item	Safety			39.026449 °	39.026449 °
				-121.726937 °	-121.726937 °
DWR ID	DWR_NA0060_22_t_2012_5				
Action/Comments					
Inspector Comments: The site has fire extinguishers on site and fall protection rails. One rail by the pump inlet needs to be replaced.

Fire extinguisher next to entrance gate. Photo taken July, 2018.

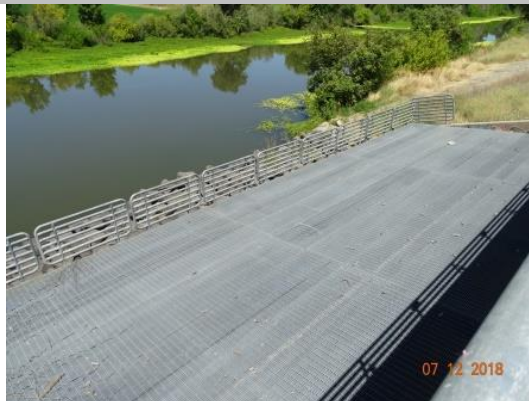
Photo 2 of 6 : ST_2018_NA0060_22_5_20180713_00028.jpg

View of protection railing and grate over outlets. Photo taken July, 2018.

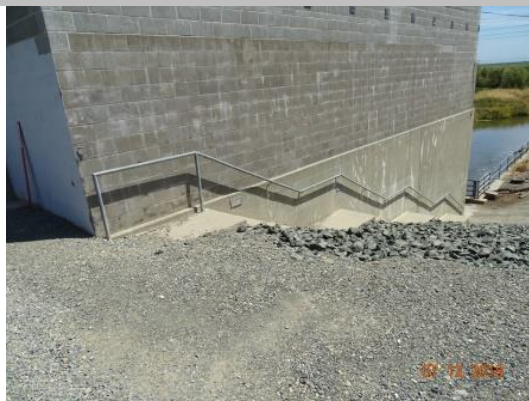
Photo 3 of 6 : ST_2018_NA0060_22_5_20180713_00029.jpg

Staircase railing down to pump inlets. Photo taken July, 2018.

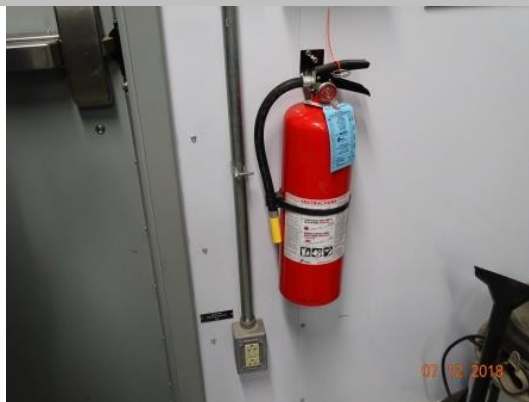
Photo 4 of 6 : ST_2018_NA0060_22_5_20180713_00026.jpg

Fire extinguisher in the pump control room. Photo taken July, 2018.

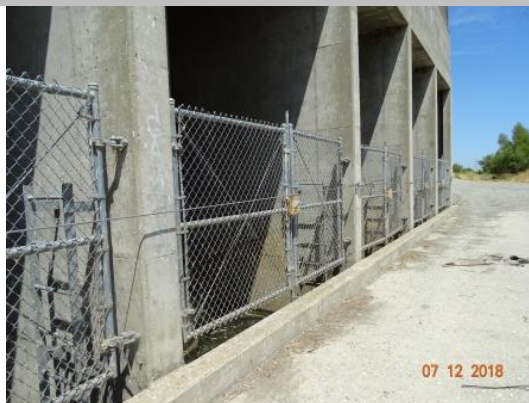
Photo 5 of 6 : ST_2018_NA0060_22_5_20180713_00030.jpg

LM Start	0.00	Rating **	M	Issue No.	5 (cont)	
LM End	0.00	Issue Type +	Ma	Location *		
Category	Pump Stations			GPS Latitude/Longitude		
				Start	End	
Item	Safety			39.026449 °	39.026449 °	
				-121.726937 °	-121.726937 °	
DWR ID	DWR_NA0060_22_t_2012_5					
Action/Comments						
Inspector Comments: The site has fire extinguishers on site and fall protection rails. One rail by the pump inlet needs to be replaced.

Fall protection cable next to pump inlets. Photo taken July, 2018.

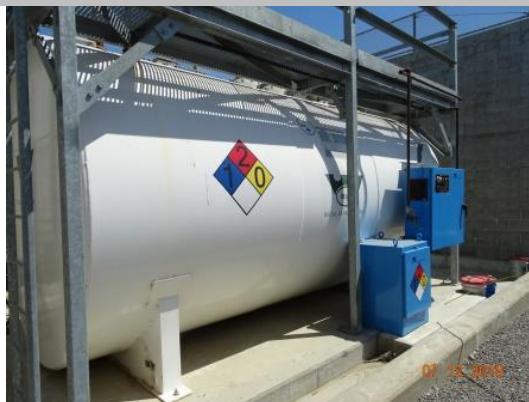
Photo 1 of 1 : ST_2018_NA0060_22_8_20180713_00033.jpg

LM Start	0.00	Rating **	A	Issue No.	8	
LM End	0.00	Issue Type +	Ma	Location *		
Category	Pump Stations			GPS Latitude/Longitude		
				Start	End	
Item	Power			39.026449 °	39.026449 °	
				-121.726937 °	-121.726937 °	
DWR ID	DWR_NA0060_22_t_2012_8					
Action/Comments						
Inspector Comments: The structure is on the grid with emergency backup generator.

View of the fuel tank for the backup generator. Photo taken July, 2018.

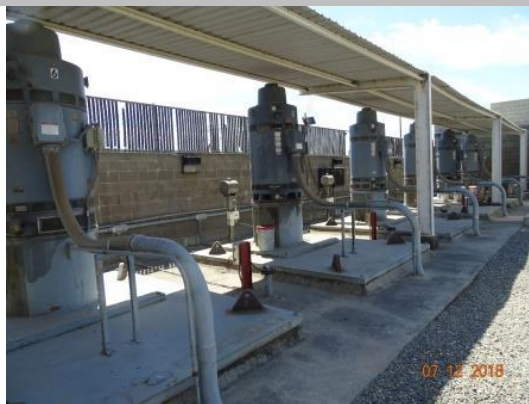
Photo 1 of 2 : ST_2018_NA0060_22_10_20180713_00034.jpg

LM Start	0.00	Rating **	A	Issue No.	10
LM End	0.00	Issue Type +	Ma	Location *	
Category	Pump Stations			GPS Latitude/Longitude	
				Start	End
Item	Motors, Engines, Fans & Gear Reducers			39.026449 °	39.026449 °
				-121.726937 °	-121.726937 °
DWR ID	DWR_NA0060_22_t_2012_10				
Action/Comments					
Inspector Comments: These items appear to be maintained and in operational condition.

View of the pump motors. Photo taken July, 2018.

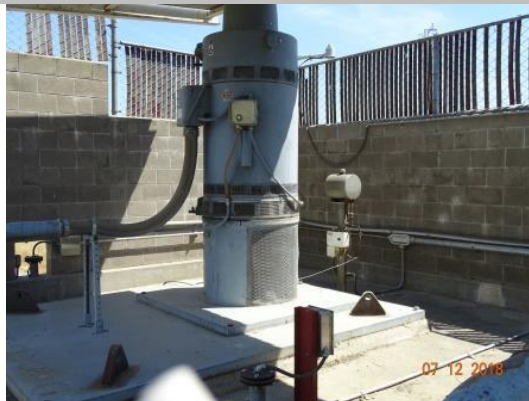
Photo 2 of 2 : ST_2018_NA0060_22_10_20180713_00035.jpg

View of one pump motor and oil tank. Photo taken July, 2018.

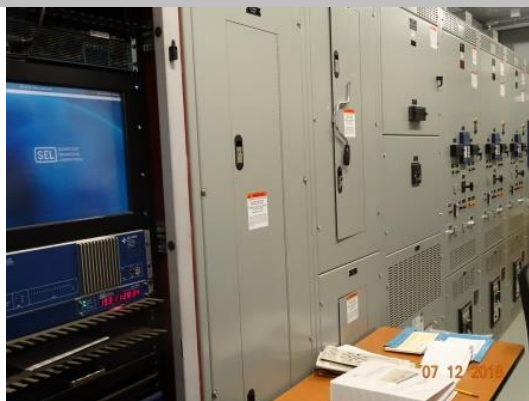
Photo 1 of 1 : ST_2018_NA0060_22_11_20180713_00036.jpg

LM Start	0.00	Rating **	A	Issue No.	11
LM End	0.00	Issue Type +	Ma	Location *	
Category	Pump Stations			GPS Latitude/Longitude	
				Start	End
Item	Pump Control Systems			39.026449 °	39.026449 °
				-121.726937 °	-121.726937 °
DWR ID	DWR_NA0060_22_t_2012_11				
Action/Comments					
Inspector Comments: Pump control systems on site are new and appear to be in working order.

View of the pump control panels. Photo taken July, 2018.

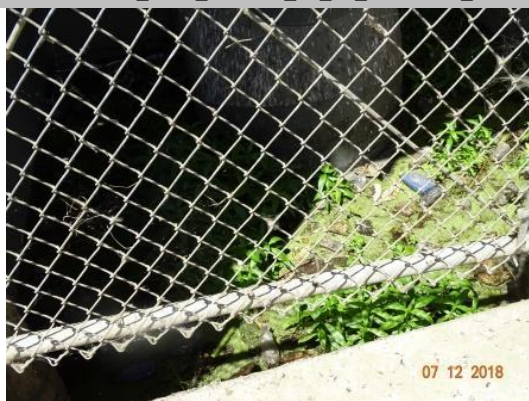
Photo 1 of 1 : ST_2018_NA0060_22_12_20180713_00037.jpg

LM Start	0.00	Rating **	M	Issue No.	12
LM End	0.00	Issue Type +	Ma	Location *	
Category	Pump Stations			GPS Latitude/Longitude	
				Start	End
Item	Sumps/Wet Well			39.026449 °	39.026449 °
				-121.726937 °	-121.726937 °
DWR ID	DWR_NA0060_22_t_2012_12				
Action/Comments					
Inspector Comments: Trash and plant debris buildup in sump number 4 should be removed.

View of plant and trash debris buildup in sump number 4. Photo taken July, 2018.

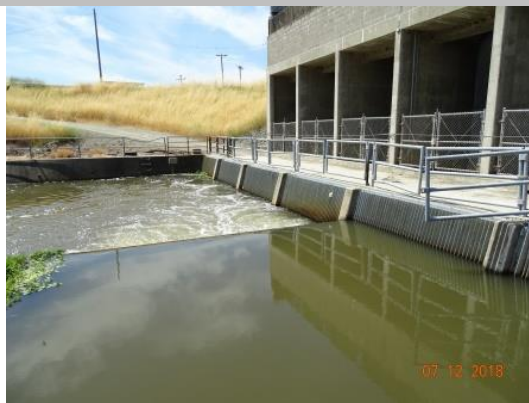
Photo 1 of 1 : ST_2018_NA0060_22_13_20180713_00038.jpg

LM Start	0.00	Rating **	A	Issue No.	13
LM End	0.00	Issue Type +	Ma	Location *	
Category	Pump Stations			GPS Latitude/Longitude	
				Start	End
Item	Trash Racks			39.026449 °	39.026449 °
				-121.726937 °	-121.726937 °
DWR ID	DWR_NA0060_22_t_2012_13				
Action/Comments					
Inspector Comments: Trash rack is secure and free of debris.

View of the trash racks. Photo taken July, 2018.

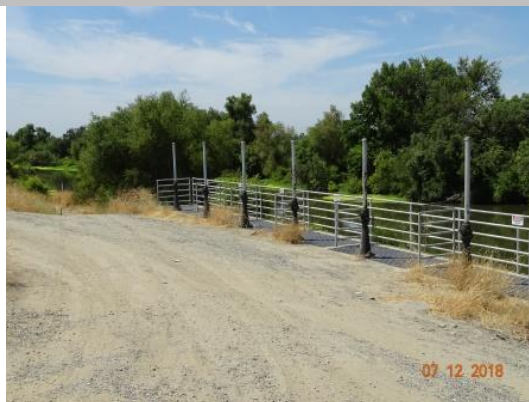
Photo 1 of 1 : ST_2018_NA0060_22_17_20180713_00039.jpg

LM Start	0.00	Rating **	A	Issue No.	17
LM End	0.00	Issue Type +	Ma	Location *	
Category	Pump Stations			GPS Latitude/Longitude	
				Start	End
Item	Manual Gate Operators			39.026449 °	39.026449 °
				-121.726937 °	-121.726937 °
DWR ID	DWR_NA0060_22_t_2012_17				
Action/Comments					
Inspector Comments: Manual gate operators appear to be in good working condition.

View of the manual gate operators. Photo taken July, 2018.

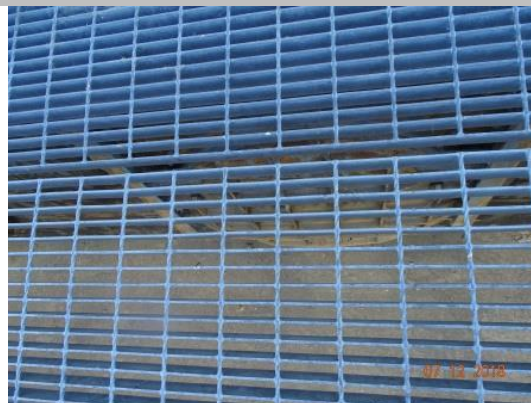
Photo 1 of 1 : ST_2018_NA0060_22_19_20180713_00040.jpg

LM Start	0.00	Rating **	A	Issue No.	19
LM End	0.00	Issue Type +	Ma	Location *	
Category	Pump Stations			GPS Latitude/Longitude	
				Start	End
Item	Flap Gates			39.026449 °	39.026449 °
				-121.726937 °	-121.726937 °
DWR ID	DWR_NA0060_22_t_2012_19				
Action/Comments					
Inspector Comments: Flap gates are in proper working condition, they show no signs of corrosion or damage.

View of a flap gate, representative of the other flap gates. Photo taken July, 2018.

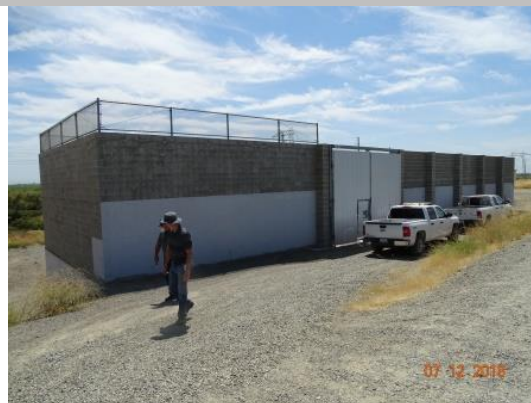
Photo 1 of 1 : ST_2018_NA0060_22_21_20180713_00041.jpg

LM Start	0.00	Rating **	A	Issue No.	21	
LM End	0.00	Issue Type +	Ma	Location *		
Category	Pump Stations			GPS Latitude/Longitude		
				Start	End	
Item	Security Fencing			39.026449 °	39.026449 °	
				-121.726937 °	-121.726937 °	
DWR ID	DWR_NA0060_22_t_2012_21					
Action/Comments						
Inspector Comments: Site is currently secured by a masonry brick wall.

Photo of security fencing and steel entrance door. Photo taken July, 2018.

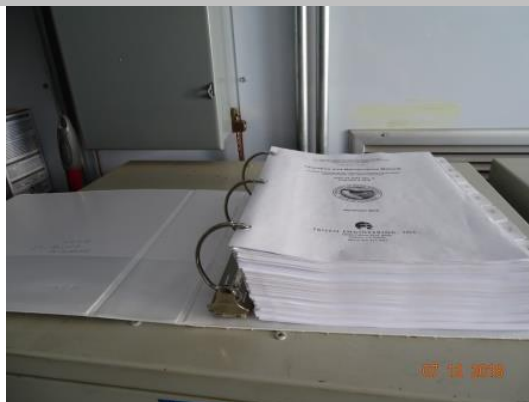
Photo 1 of 1 : ST_2018_NA0060_23_2_20180712_00021.jpg

LM Start	0.00	Rating **	A	Issue No.	2	
LM End	0.00	Issue Type +	Ma	Location *		
Category	Pump Stations			GPS Latitude/Longitude		
				Start	End	
Item	Operation & Maintenance Manual			39.120096 °	39.120096 °	
				-121.779230 °	-121.779230 °	
DWR ID	DWR_NA0060_23_t_2012_2					
Action/Comments						
Inspector Comments: O&M Manual is present at the site. Sutter Maintenance Yard will provide documentation of maintenance going forward.

Photo of the O&M manual. Photo taken July, 2018.

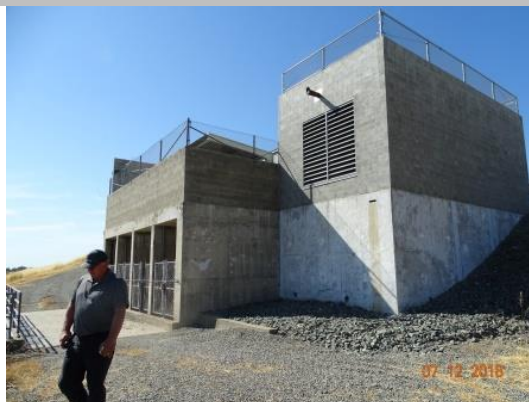
Photo 1 of 3 : ST_2018_NA0060_23_3_20180712_00022.jpg

LM Start	0.00	Rating **	A	Issue No.	3
LM End	0.00	Issue Type +	Ma	Location *	
Category	Pump Stations			GPS Latitude/Longitude	
				Start	End
Item	Plant Building			39.120096 °	39.120096 °
				-121.779230 °	-121.779230 °
DWR ID	DWR_NA0060_23_t_2012_3				
Action/Comments					
Inspector Comments: Plant building appears to be in good working condition.

Looking south at the building. Photo taken July, 2018.

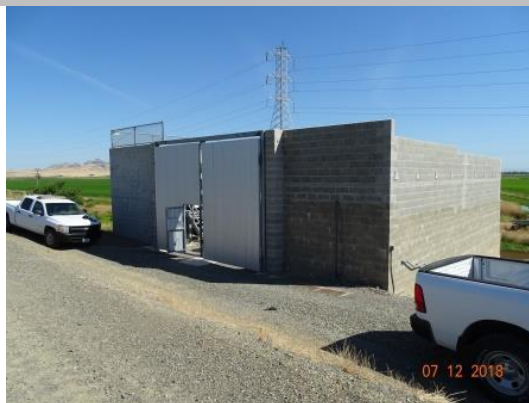
Photo 2 of 3 : ST_2018_NA0060_23_3_20180712_00023.jpg

Looking north at the building. Photo taken July, 2018.

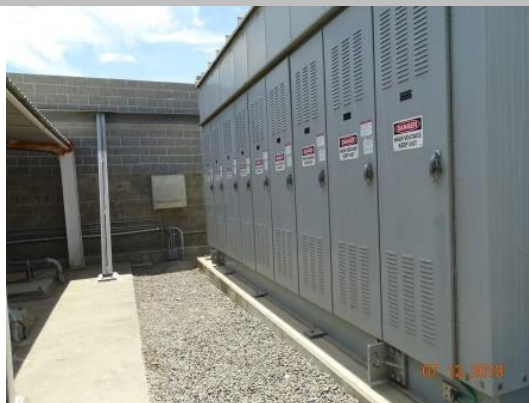
Photo 3 of 3 : ST_2018_NA0060_23_3_20180713_00040.jpg

View of back side of pump control building. Photo taken July, 2018.

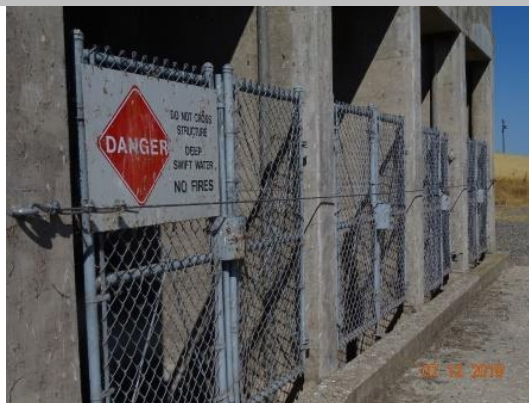
Photo 1 of 5 : ST_2018_NA0060_23_5_20180712_00025.jpg

LM Start	0.00	Rating **	A	Issue No.	5
LM End	0.00	Issue Type +	Ma	Location *	
Category	Pump Stations			GPS Latitude/Longitude	
				Start	End
Item	Safety			39.120096 °	39.120096 °
				-121.779230 °	-121.779230 °
DWR ID	DWR_NA0060_23_t_2012_5				
Action/Comments					
Inspector Comments: The site has fire extinguishers on site and fall protection rails.

View of fall protection cable. Photo taken July, 2018.

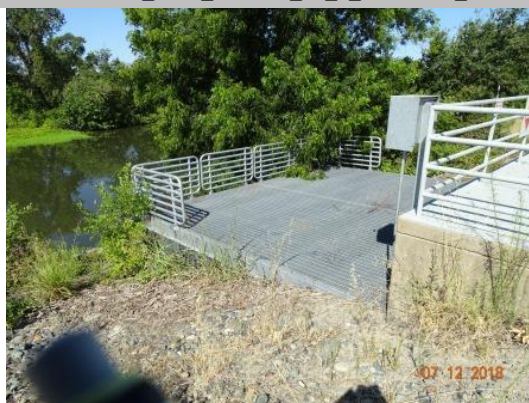
Photo 2 of 5 : ST_2018_NA0060_23_5_20180712_00026.jpg

View of fall protection fences and grate at the outlets. Photo taken July, 2018.

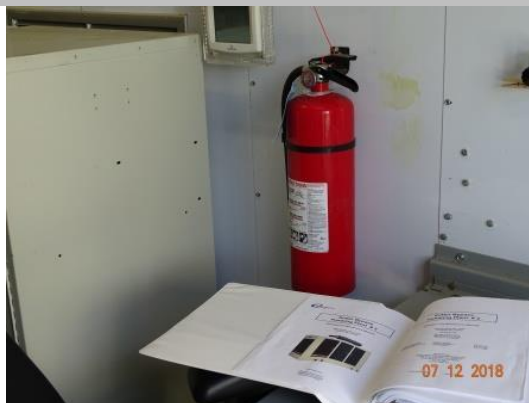
Photo 3 of 5 : ST_2018_NA0060_23_5_20180712_00027.jpg

Fire extinguisher in the control room. Photo taken July, 2018.

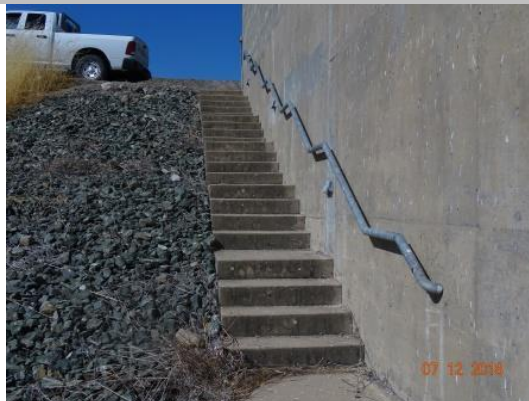
Photo 4 of 5 : ST_2018_NA0060_23_5_20180712_00024.jpg

Staircase railing leading down pump intakes. Photo taken July, 2018.

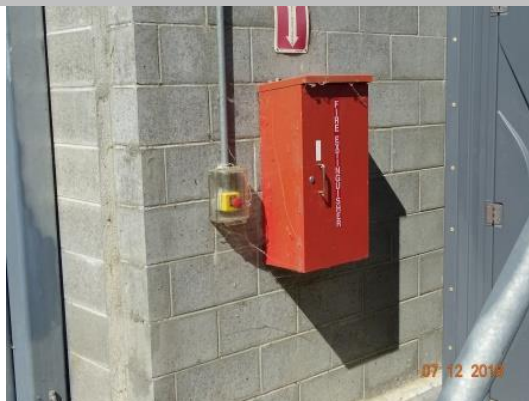
Photo 5 of 5 : ST_2018_NA0060_23_5_20180712_00028.jpg

Fire extinguisher next to security gate. Photo taken July, 2018.

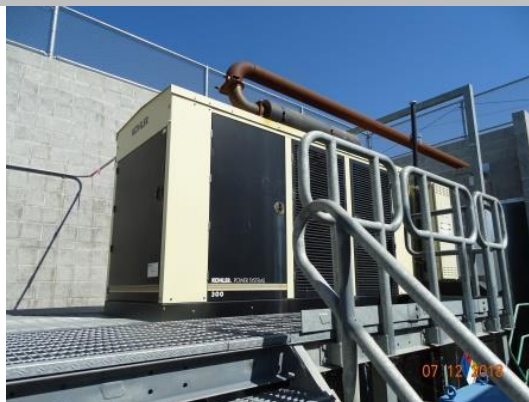
Photo 1 of 1 : ST_2018_NA0060_23_8_20180712_00029.jpg

LM Start	0.00	Rating **	A	Issue No.	8	
LM End	0.00	Issue Type +	Ma	Location *		
Category	Pump Stations			GPS Latitude/Longitude		
				Start	End	
Item	Power			39.120096 °	39.120096 °	
				-121.779230 °	-121.779230 °	
DWR ID	DWR_NA0060_23_t_2012_8					
Action/Comments						
Inspector Comments: The structure is on the grid with emergency generator backup.

Photo of backup generator. Photo taken July, 2018.

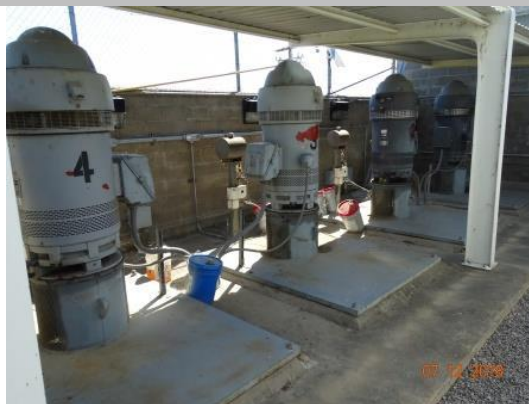
Photo 1 of 2 : ST_2018_NA0060_23_10_20180712_00030.jpg

LM Start	0.00	Rating **	A	Issue No.	10
LM End	0.00	Issue Type +	Ma	Location *	
Category	Pump Stations			GPS Latitude/Longitude	
				Start	End
Item	Motors, Engines, Fans & Gear Reducers			39.120096 °	39.120096 °
				-121.779230 °	-121.779230 °
DWR ID	DWR_NA0060_23_t_2012_10				
Action/Comments					
Inspector Comments: These items appear to be maintained and in operating condition.

View of the pump motors. Photo taken July, 2018.

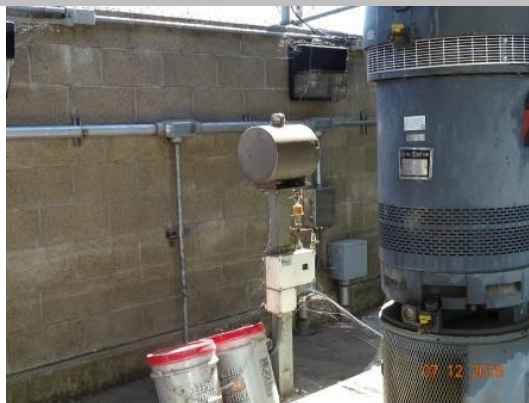
Photo 2 of 2 : ST_2018_NA0060_23_10_20180712_00033.jpg

View of the oil tank for each pump. Photo taken July, 2018.

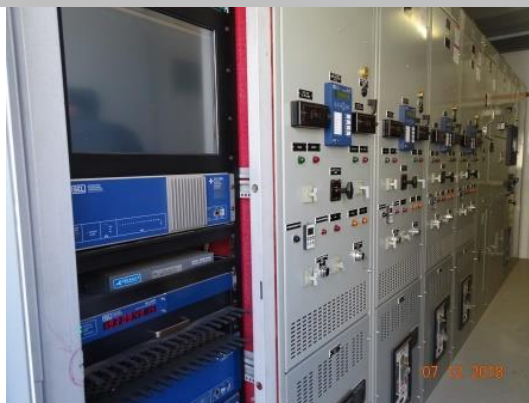
Photo 1 of 2 : ST_2018_NA0060_23_11_20180712_00034.jpg

LM Start	0.00	Rating **	A	Issue No.	11
LM End	0.00	Issue Type +	Ma	Location *	
Category	Pump Stations			GPS Latitude/Longitude	
				Start	End
Item	Pump Control Systems			39.120096 °	39.120096 °
				-121.779230 °	-121.779230 °
DWR ID	DWR_NA0060_23_t_2012_11				
Action/Comments					
Inspector Comments: Pump control systems on site are new and appear to be in working order.

View of the pump control panels. Photo taken July, 2018.

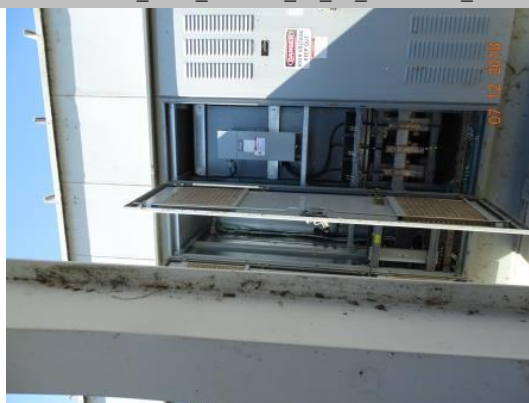
Photo 2 of 2 : ST_2018_NA0060_23_11_20180712_00035.jpg

View of the wiring for the pump control panel. Photo taken July, 2018.

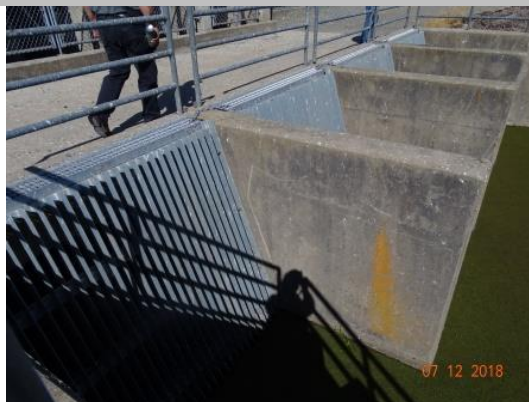
Photo 1 of 2 : ST_2018_NA0060_23_13_20180712_00036.jpg

LM Start	0.00	Rating **	A	Issue No.	13
LM End	0.00	Issue Type +	Ma	Location *	
Category	Pump Stations			GPS Latitude/Longitude	
				Start	End
Item	Trash Racks			39.120096 °	39.120096 °
				-121.779230 °	-121.779230 °
DWR ID	DWR_NA0060_23_t_2012_13				
Action/Comments					
Inspector Comments: No debris present on trash racks, they appear to be in good condition.

View of the trash racks. Photo taken July, 2018.

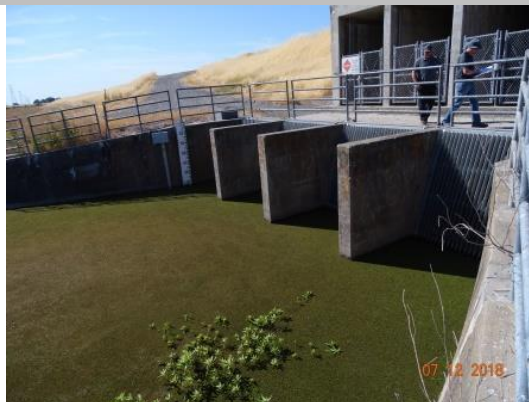
Photo 2 of 2 : ST_2018_NA0060_23_13_20180712_00037.jpg

View of the trash racks showing no debris buildup. Photo taken July, 2018.

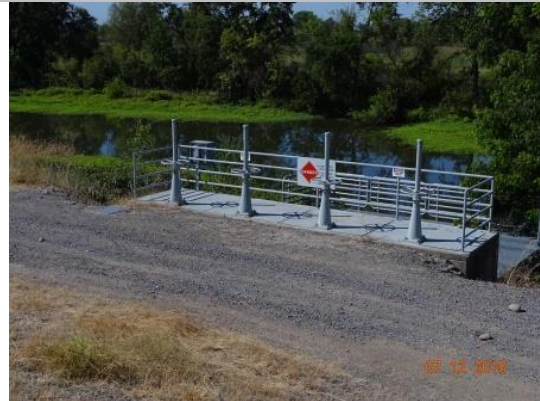
Photo 1 of 1 : ST_2018_NA0060_23_17_20180712_00038.jpg

LM Start	0.00	Rating **	M	Issue No.	17
LM End	0.00	Issue Type +	Ma	Location *	
Category	Pump Stations			GPS Latitude/Longitude	
				Start	End
Item	Manual Gate Operators			39.120096 °	39.120096 °
				-121.779230 °	-121.779230 °
DWR ID	DWR_NA0060_23_t_2012_17				
Action/Comments					
Inspector Comments: Manual gate operators should be lubricated. Gate operatorof the second most downstream gate needs to be fixed so it can be opened.

View of the screw gate openers. Photo taken July, 2018.

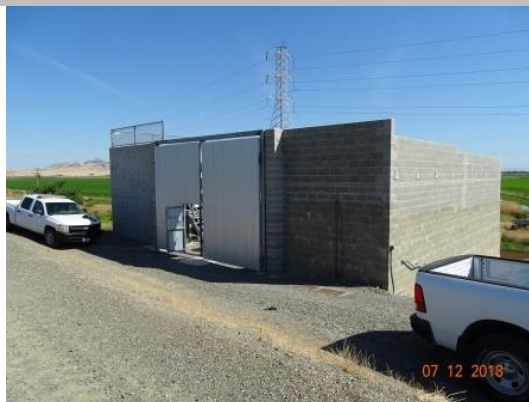
Photo 1 of 1 : ST_2018_NA0060_23_21_20180712_00039.jpg

LM Start	0.00	Rating **	A	Issue No.	21
LM End	0.00	Issue Type +	Ma	Location *	
Category	Pump Stations			GPS Latitude/Longitude	
				Start	End
Item	Security Fencing			39.120096 °	39.120096 °
				-121.779230 °	-121.779230 °
DWR ID	DWR_NA0060_23_t_2012_21				
Action/Comments					
Inspector Comments: Site is currently secured by a masonry brick wall.

View of the concrete wall and steel security gate that surrounds the pump. Photo taken July, 2018.

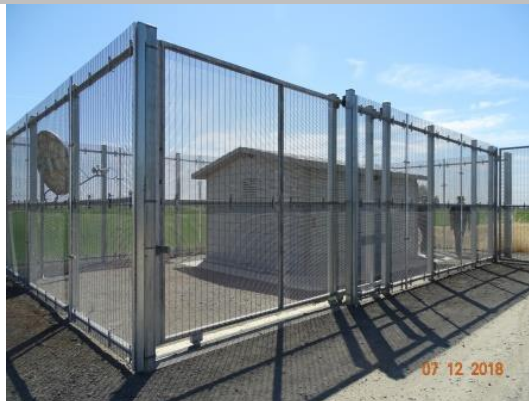
Photo 1 of 4 : ST_2018_NA0060_10_1_20180713_00023.jpg

View of weir and fish ladder control building. Photo taken July, 2018.

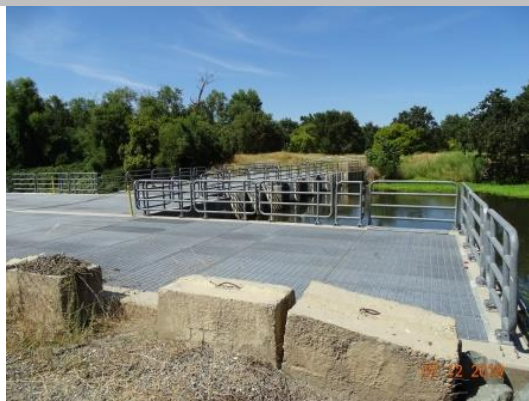
Photo 2 of 4 : ST_2018_NA0060_10_1_20180713_00024.jpg

View of top of weir and fish ladder. Photo taken July, 2018.

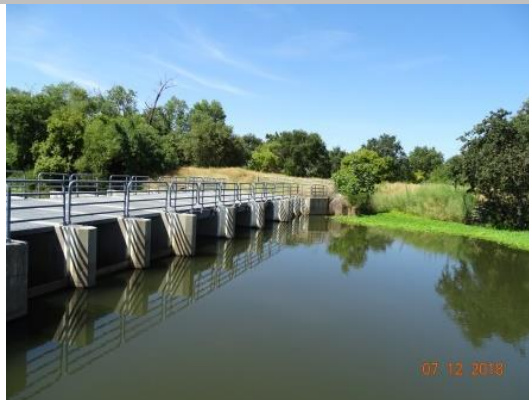
Photo 3 of 4 : ST_2018_NA0060_10_1_20180713_00025.jpg

View of upstream side of weir. Photo taken July, 2018.

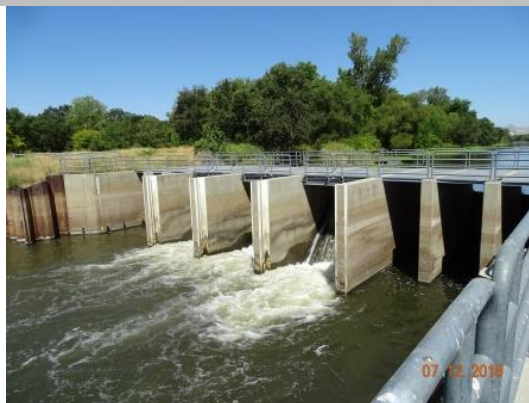
Photo 4 of 4 : ST_2018_NA0060_10_1_20180713_00026.jpg

View of downstream side of weir. Photo taken July, 2018.

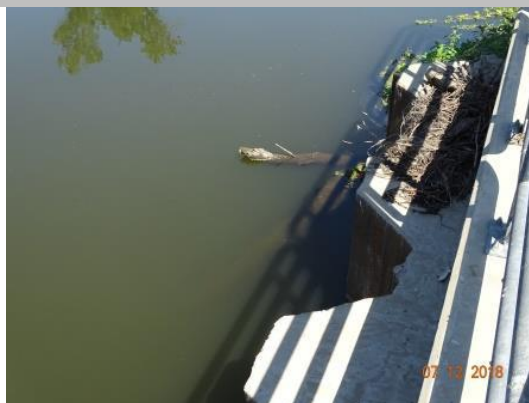
Photo 1 of 1 : ST_2018_NA0060_10_2_20180713_00027.jpg

LM Start	0.00	Rating **	M	Issue No.	2
LM End	0.00	Issue Type +	Ma	Location *	
Category	Structures & Concrete Lined Channels	GPS Latitude/Longitude			
		Start		End	
Item	Vegetation & Obstructions	39.102526 °		39.102526 °	
		-121.758682 °		-121.758682 °	
DWR ID	DWR_NA0060_10_t_2012_2				
Action/Comments					
Inspector Comments: Log blocking part of upstream end of fish ladder.

View of log blocking part of upstream end of fish ladder. Photo taken July, 2018.

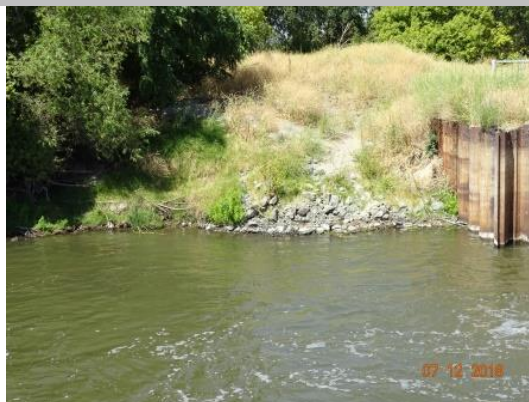
Photo 1 of 2 : ST_2018_NA0060_10_5_20180713_00028.jpg

LM Start	0.00	Rating **	A	Issue No.	5
LM End	0.00	Issue Type +	Ma	Location *	
Category	Structures & Concrete Lined Channels			GPS Latitude/Longitude	
				Start	End
Item	Revetments			39.102526 °	39.102526 °
				-121.758682 °	-121.758682 °
DWR ID	DWR_NA0060_10_t_2012_5				
Action/Comments					
Inspector Comments: Existing riprap protection is properly maintained and is undamaged. Riprap clearly visible.

View of revetment of the downstream right bank. Photo taken July, 2018.

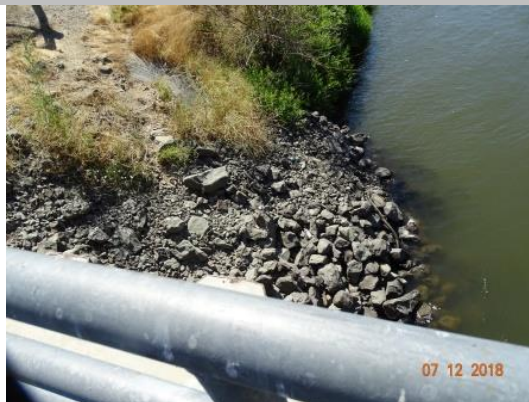
Photo 2 of 2 : ST_2018_NA0060_10_5_20180713_00029.jpg

View of revetment on the downstream left bank. Photo taken July, 2018.

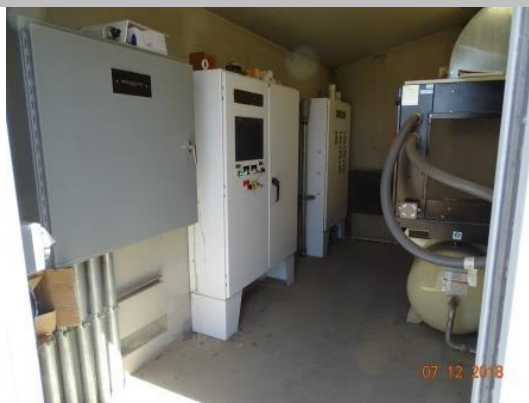
Photo 1 of 1 : ST_2018_NA0060_10_13_20180713_00031.jpg

LM Start	0.00	Rating **	A	Issue No.	13
LM End	0.00	Issue Type +	Ma	Location *	
Category	Structures & Concrete Lined Channels			GPS Latitude/Longitude	
				Start	End
Item	Electric Gate Operators			39.102526 °	39.102526 °
				-121.758682 °	-121.758682 °
DWR ID	DWR_NA0060_10_t_2012_13				
Action/Comments					
Inspector Comments: The sluice gates are opened and closed by the inflation/deflation of a bladder. The compressors' are located in the building on the left bank of the levee crown and are functioning properly.

View of control panel, air compressor, and generator. Photo taken July, 2018.

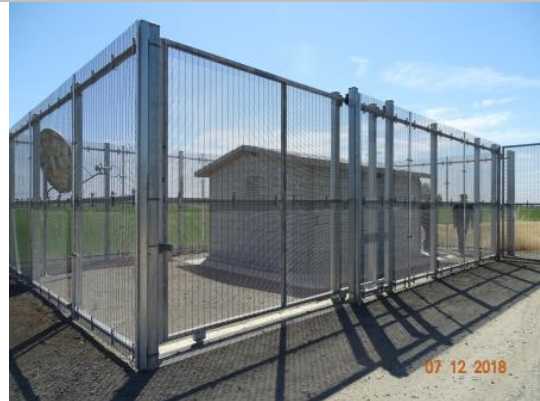
Photo 1 of 1 : ST_2018_NA0060_10_18_20180713_00032.jpg

LM Start	0.00	Rating **	A	Issue No.	18
LM End	0.00	Issue Type +	Ma	Location *	
Category	Structures & Concrete Lined Channels			GPS Latitude/Longitude	
				Start	End
Item	Security Fencing			39.102526 °	39.102526 °
				-121.758682 °	-121.758682 °
DWR ID	DWR_NA0060_10_t_2012_18				
Action/Comments					
Inspector Comments: Safety / security fencing is good condition and provides protection against falling or unauthorized access. Gates open and close freely, locks are in place, and there is little corrosion on metal parts. The fence is very close to the hing point of the slope and does not allow access around the out side of the fence in this location.

View of security fence around the weir and fish ladder control building.
Photo taken July, 2018.

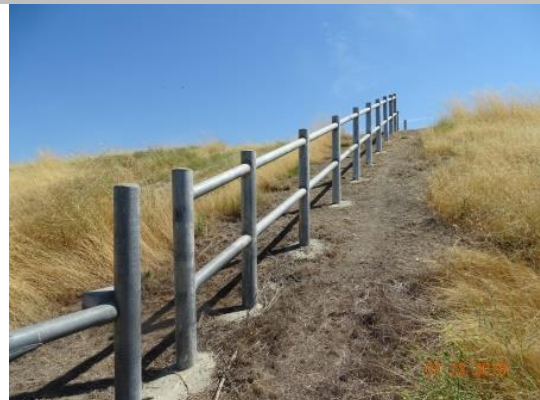
Photo 1 of 3 : ST_2018_NA0060_10_23_20180713_00034.jpg

LM Start	0.00	Rating **	A	Issue No.	23
LM End	0.00	Issue Type +	Ma	Location *	
Category	Structures & Concrete Lined Channels			GPS Latitude/Longitude	
				Start	End
Item	Safety			39.102526 °	39.102526 °
				-121.758682 °	-121.758682 °
DWR ID	DWR_NA0060_10_t_2012_23				
Action/Comments					
Inspector Comments: Safety hardware installed. Adequate protection for fall hazards exist. No hazardous conditions that might affect the operation of the structure. Fire extinguisher is located in in the compressor building and is current.

View of railing on waterside levee slope between weir and levee crown.
Photo taken July, 2018.

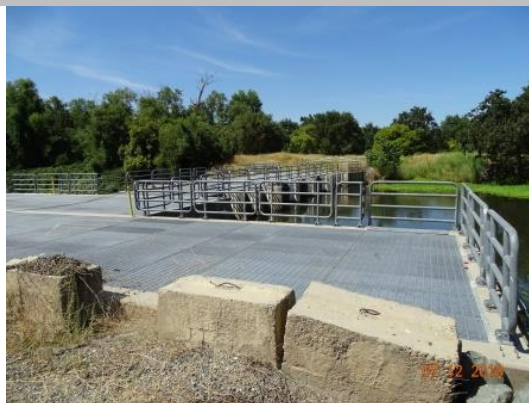
Photo 2 of 3 : ST_2018_NA0060_10_23_20180713_00035.jpg

View of fall protection railing. Photo taken July, 2018.

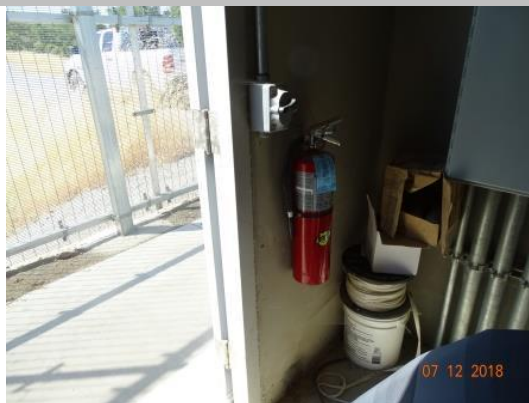
Photo 3 of 3 : ST_2018_NA0060_10_23_20180713_00033.jpg

Fire extinguisher in the weir and fish ladder control building. Photo taken July, 2018.

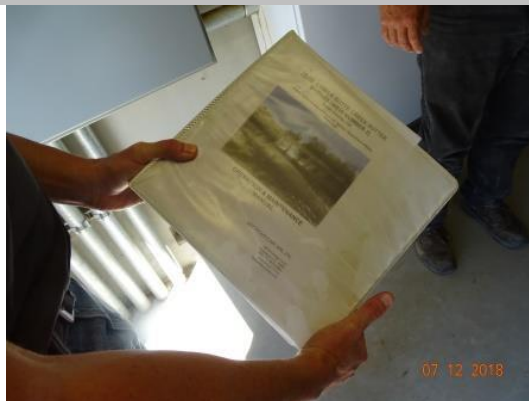
Photo 1 of 1 : ST_2018_NA0060_10_24_20180713_00036.jpg

LM Start	0.00	Rating **	A	Issue No.	24
LM End	0.00	Issue Type +	Ma	Location *	
Category	Structures & Concrete Lined Channels			GPS Latitude/Longitude	
				Start	End
Item	Operation & Maintenance Manual			39.102526 °	39.102526 °
				-121.758682 °	-121.758682 °
DWR ID	DWR_NA0060_10_t_2013_24				
Action/Comments					
Inspector Comments: Sutter Maintenance Yard has a copy of the O&M at the site.

View of the O&M manual. Photo taken July, 2018.

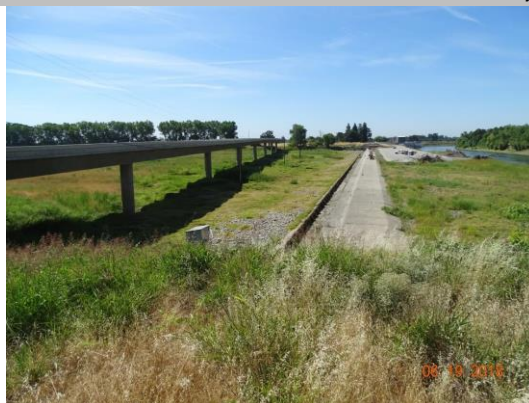
Photo 1 of 5 : ST_2018_NA0060_3_1_20180619_00031.jpg

View of the weir from the north side. Summer 2018.

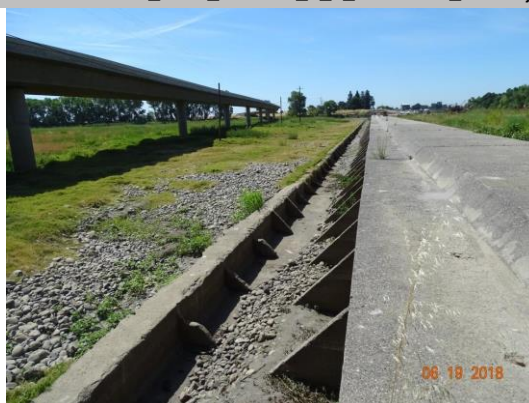
Photo 2 of 5 : ST_2018_NA0060_3_1_20180619_00032.jpg

View of the stilling basin from the north end of the weir. Summer 2018.

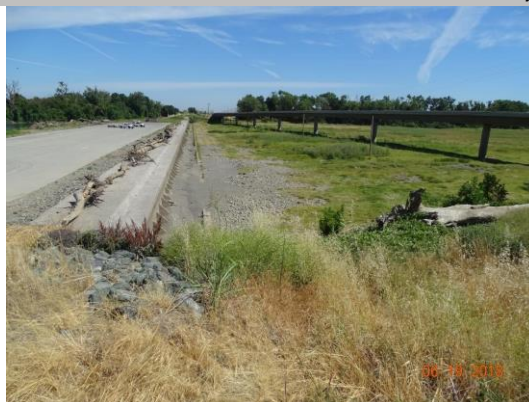
Photo 3 of 5 : ST_2018_NA0060_3_1_20180619_00033.jpg

View of the weir from the south side. Summer 2018.

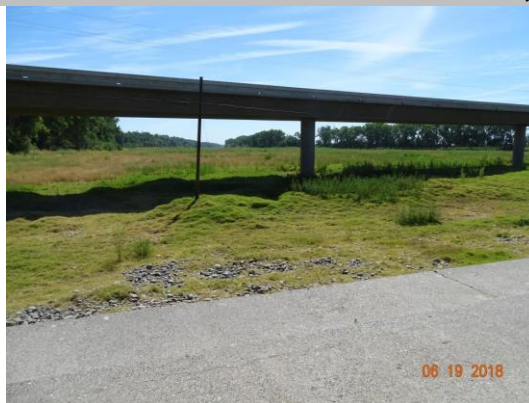
Photo 4 of 5 : ST_2018_NA0060_3_1_20180619_00034.jpg

Downstream view of Tisdale Bypass. Summer 2018.

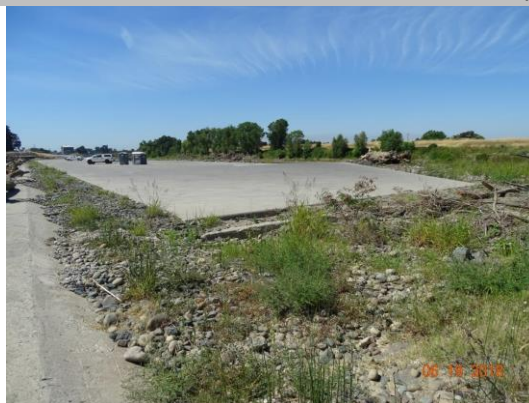
Photo 5 of 5 : ST_2018_NA0060_3_1_20180619_00035.jpg

Upstream view of adjacent parking lot. Summer 2018.

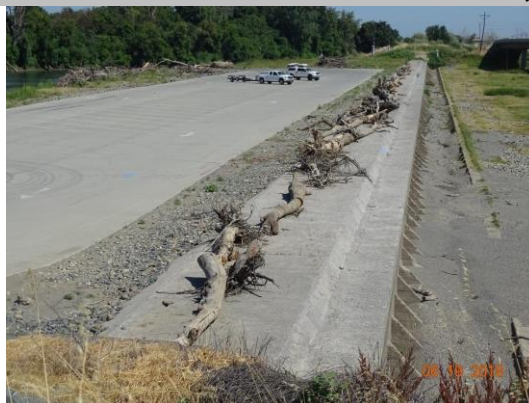
Photo 1 of 1 : ST_2018_NA0060_3_2_20180619_00050.jpg

LM Start	0.00	Rating **	M	Issue No.	2
LM End	0.00	Issue Type +	Ma	Location *	
Category	Structures & Concrete Lined Channels			GPS Latitude/Longitude	
				Start	End
Item	Vegetation & Obstructions			39.026713 °	39.026713 °
				-121.821995 °	-121.821995 °
DWR ID	DWR_NA0060_3_t_2012_2				
Action/Comments					
Inspector Comments: Scattered logs on the upstream side need to be removed.

View of logs placed along the top of the weir. Summer 2018.

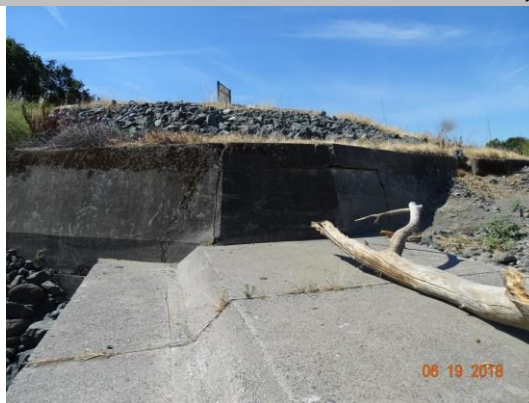
Photo 1 of 3 : ST_2018_NA0060_3_5_20180619_00036.jpg

LM Start	0.00	Rating **	M	Issue No.	5	
LM End	0.00	Issue Type +	Ma	Location *		
Category	Structures & Concrete Lined Channels			GPS Latitude/Longitude		
				Start	End	
Item	Revetments			39.026713 °	39.026713 °	
				-121.821995 °	-121.821995 °	
DWR ID	DWR_NA0060_3_t_2012_5					
Action/Comments						
Inspector Comments: Existing riprap is undamaged, but vegetation should be cleared and sprayed.

View of south abutment and revetment. Summer 2018.

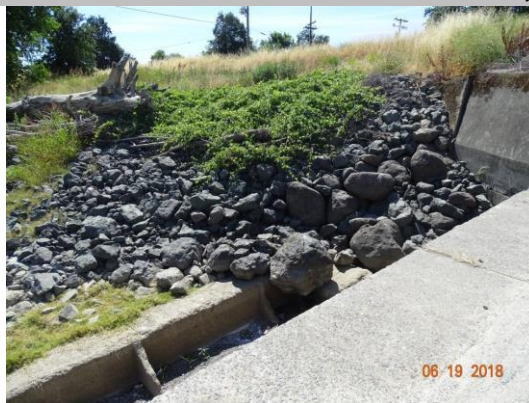
Photo 2 of 3 : ST_2018_NA0060_3_5_20180619_00047.jpg

LM Start	0.00	Rating **	M	Issue No.	5 (cont)	
LM End	0.00	Issue Type +	Ma	Location *		
Category	Structures & Concrete Lined Channels			GPS Latitude/Longitude		
				Start		End
Item	Revetments			39.026713 °		39.026713 °
				-121.821995 °		-121.821995 °
DWR ID	DWR_NA0060_3_t_2012_5					
Action/Comments						
Inspector Comments: Existing riprap is undamaged, but vegetation should be cleared and sprayed.

Additional view of revetment on the south end of the weir. Summer 2018.

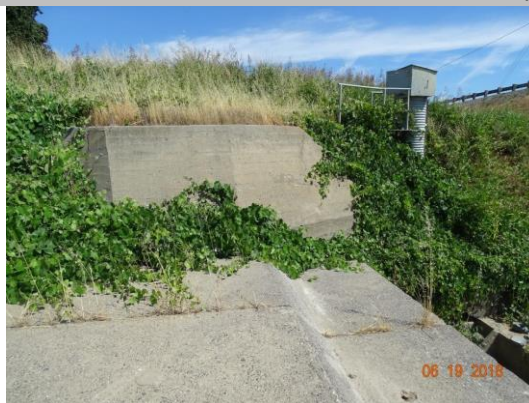
Photo 3 of 3 : ST_2018_NA0060_3_5_20180619_00037.jpg

Revetment on north abutment is blocked by heavy vegetation. Summer 2018.

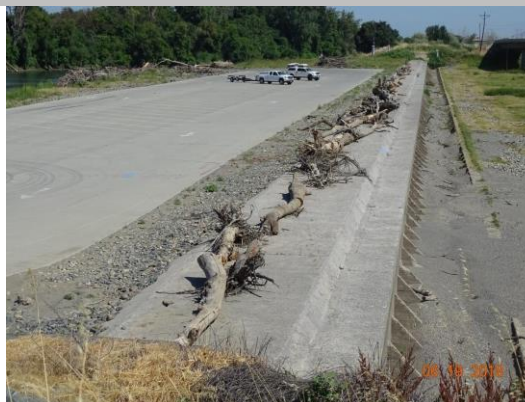
Photo 1 of 2 : ST_2018_NA0060_3_23_20180619_00049.jpg

LM Start	0.00	Rating **	M	Issue No.	23
LM End	0.00	Issue Type +	Ma	Location *	
Category	Structures & Concrete Lined Channels			GPS Latitude/Longitude	
				Start	End
Item	Safety			39.026713 °	39.026713 °
				-121.821995 °	-121.821995 °
DWR ID	DWR_NA0060_3_t_2012_23				
Action/Comments					
Inspector Comments: Concrete should be repaired to conceal the exposed rebar. Safety fence is needed for protecting the structure from the public parking lot, the logs at the edge of lot need to be removed and not used as a barrier.

The safety fence was removed due to flows over the weir, and logs were placed to keep vehicles from driving over the edge. Logs need to be removed and the safety fence replaced like it was before. Summer 2018.

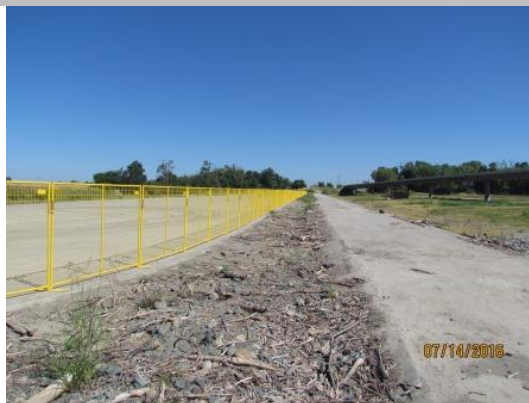
Photo 2 of 2 : ST_2018_NA0060_3_23_20180612_00030.jpg

View of safety fence separating the weir from the public parking lot in 2016.
